APP/ REF; 22/03560/OUT

## 2. Problems identified from this audit

## Bowden Road, Templecombe, Somerset

Stage 1 Road Safety Audit

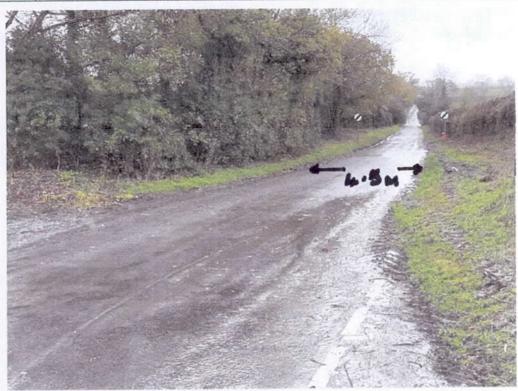
Problem 1
Location	Site access
Summary	Provision of centre line on Bowden Road

Centre lines are unachievable due to the width of Bowden Road (4.5 metres) Collisions are highly likely to occur. Signage would not necessarily reduce potential danger, their position would cause confusion in relation to the unsigned junction from Bowden Road into West Street a short distance away.

Centre line markings are proposed on Bowden Road, in order to highlight the presence of the site access junction. The carriageway is not sufficiently wide enough (< 5.5 metres) to accommodate centre line markings, resulting in narrow through lanes. This may cause collisions between passing vehicles along Bowden Road.

Provide alternative method of highlighting junction such as junction ahead signage

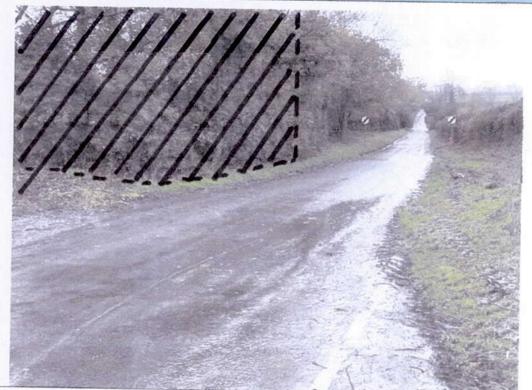
Problem 2	
Location	Site access
Summary	Intervisibility between entering and exiting vehicles

Analysis of inter visibility between vehicles entering and exiting access indicates that a refuse lorry turning left into site would overhang the exit lane of the access resulting in collisions. In addition large swathe of trees and shrubs would need to be cleared to achieve intervisibity.

Swept path analysis for a refuse vehicle indicates that for the left-turn in movement, the vehicle will overhang the exit lane of the access. Existing trees to the east of the access will obscure from sight entering vehicles. This may result in collisions between vehicles entering and exiting the site.

Provide low level planting or cut back vegetation.
