# **Dolphin Hotel, Wincanton, Somerset**

## **Ecological Impact Assessment (Bats and Birds)**

**November 2022**

Ref: 1724B-EcIA-VB

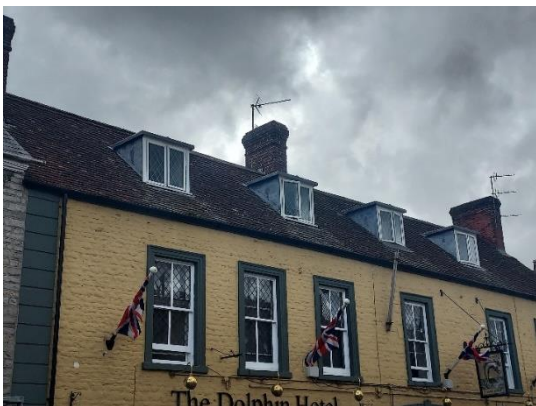
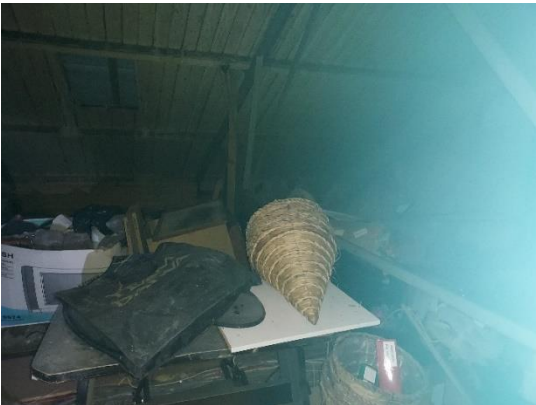
| Building Ref. | Description of Building/PRFs/Evidence | Photograph | Suitability |
|---|---|---|---|
| Dolphin Hotel | <p>Exterior – A two-storey red brick and rendered brick building with a multi-pitched slate and tiled roof. The roof was in good condition, with no missing or cracked tiles, no lifted ridge tiles and with tight lead flashing.</p> <p>Interior – One loft space above the main hotel building had been converted, but the remaining loft space was inspected. It was well sealed, clean and of sound construction. The roof struts were in good condition and the loft was insulated throughout with fibreglass insulation. The loft was used for storage.</p> | | Negligible |

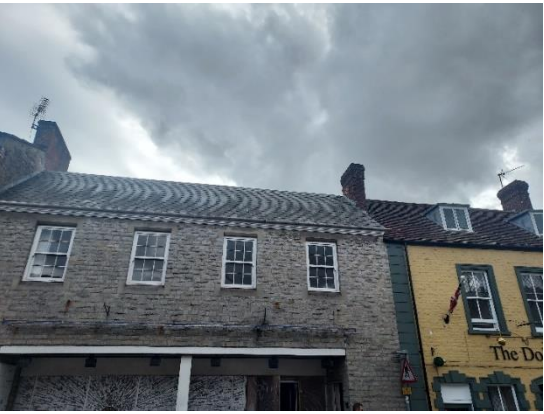
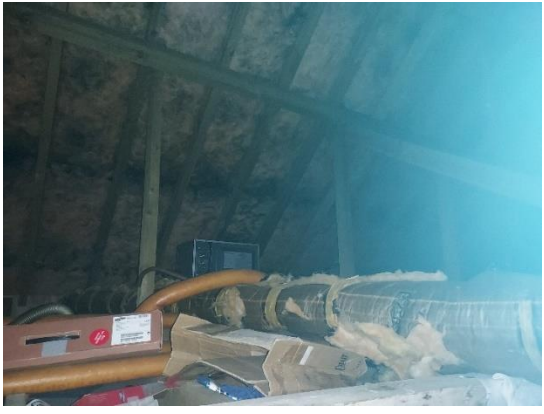
| <p>Co-Op building</p> | <p>Exterior – A two storey, stone building with a single pitched slate roof. The roof was in very good condition, with no missing or cracked tiles, no lifted ridge tiles and with tight lead flashing. The walls and roof were well-sealed with no obvious access into the roof void from the outside.</p> <p>Interior – The single loft space was accessible. It was well sealed, fairly clean and of sound construction. The roof struts were in good condition and the loft was insulated throughout with fibreglass insulation. The loft was used for storage but didn't look to have been disturbed recently.</p> | | <p>Negligible</p> |

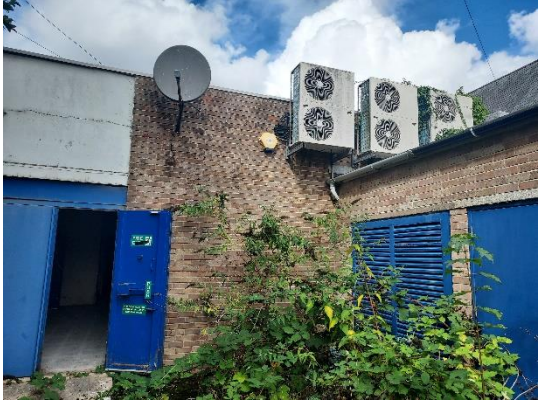
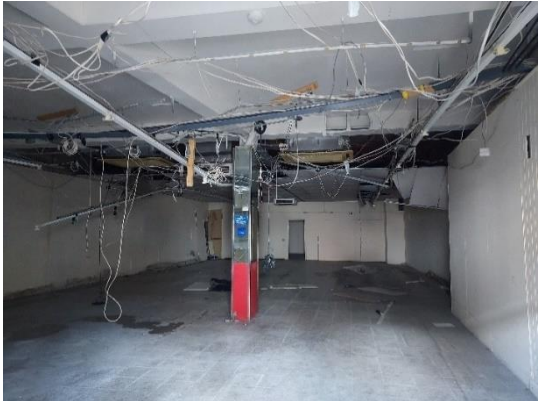
| <p>Warehouse</p> | <p>Exterior – The warehouse to the rear of the Co-op building is a flat roofed single-story red brick building, which attaches to the Dolphin Hotel along the western aspect. The roof is well sealed from the outside and there is no loft space present. The building was generally in a good state of repair externally and lacked features that could be utilised by roosting bats, such as lifted roof tiles or lifted lead flashing.</p> <p>Interior – The warehouse had been left unused for several years and was in a fairly poor state internally. No evidence of bats or potential roosting features were identified.</p> | | <p>Negligible</p> |

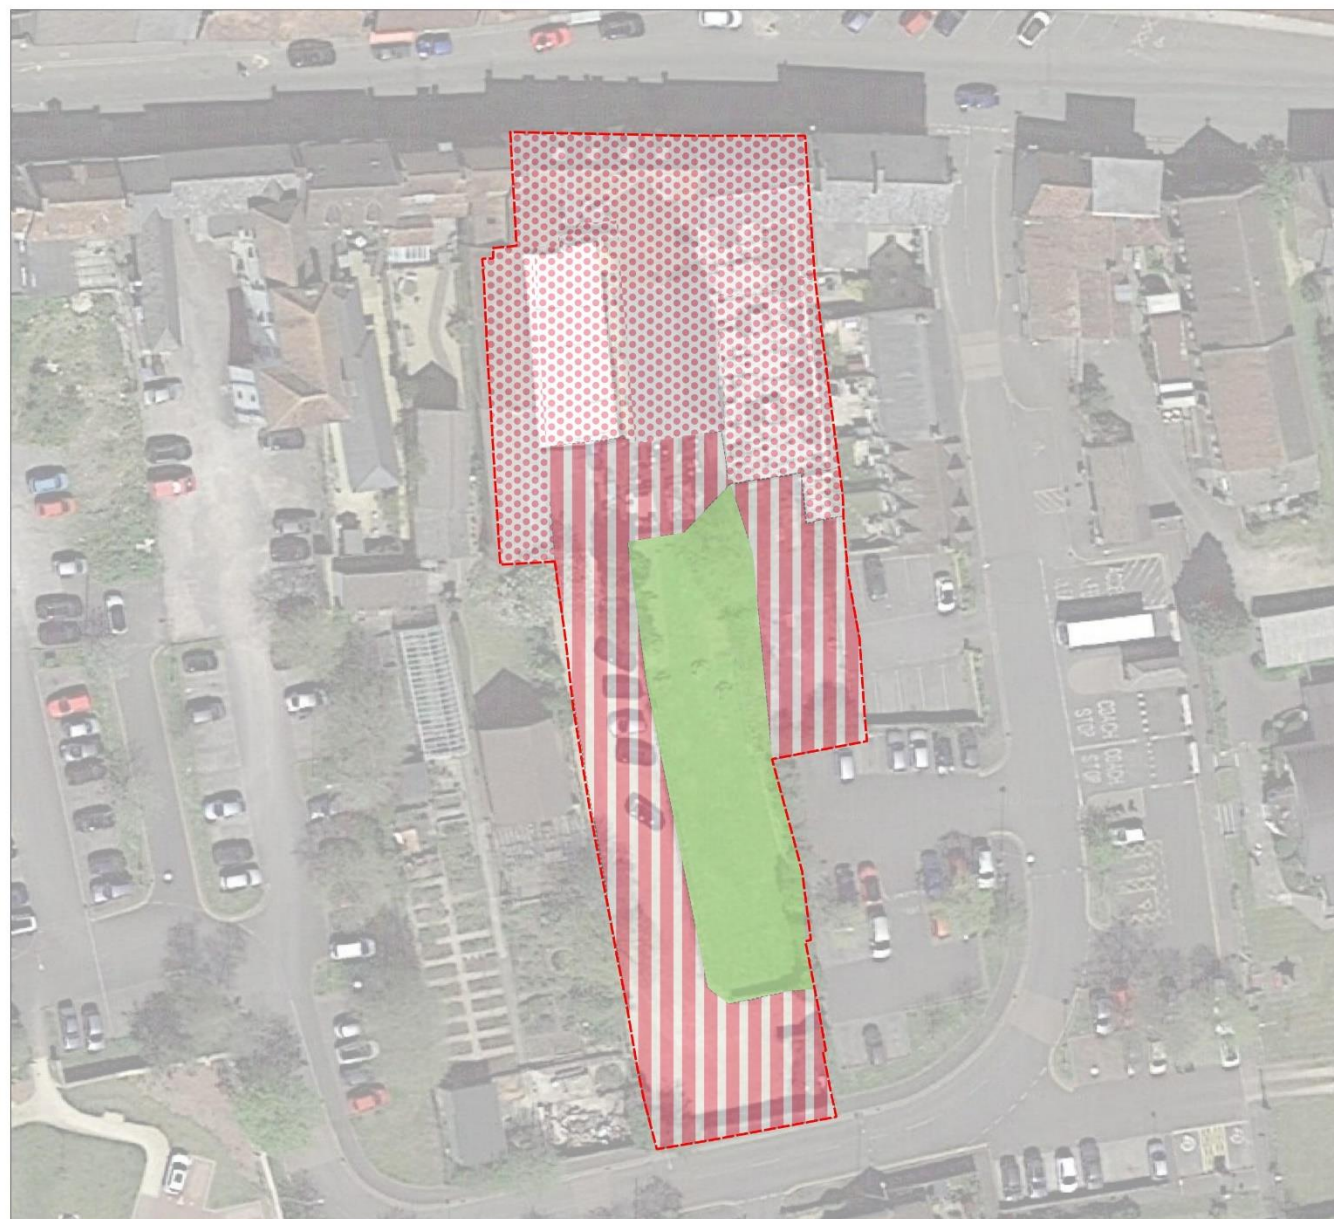
**Figure 1:**  
Baseline BNG Plan

**Figure 1** shows the Baseline BNG habitats and **Figure 2** shows the Post Development BNG habitats.

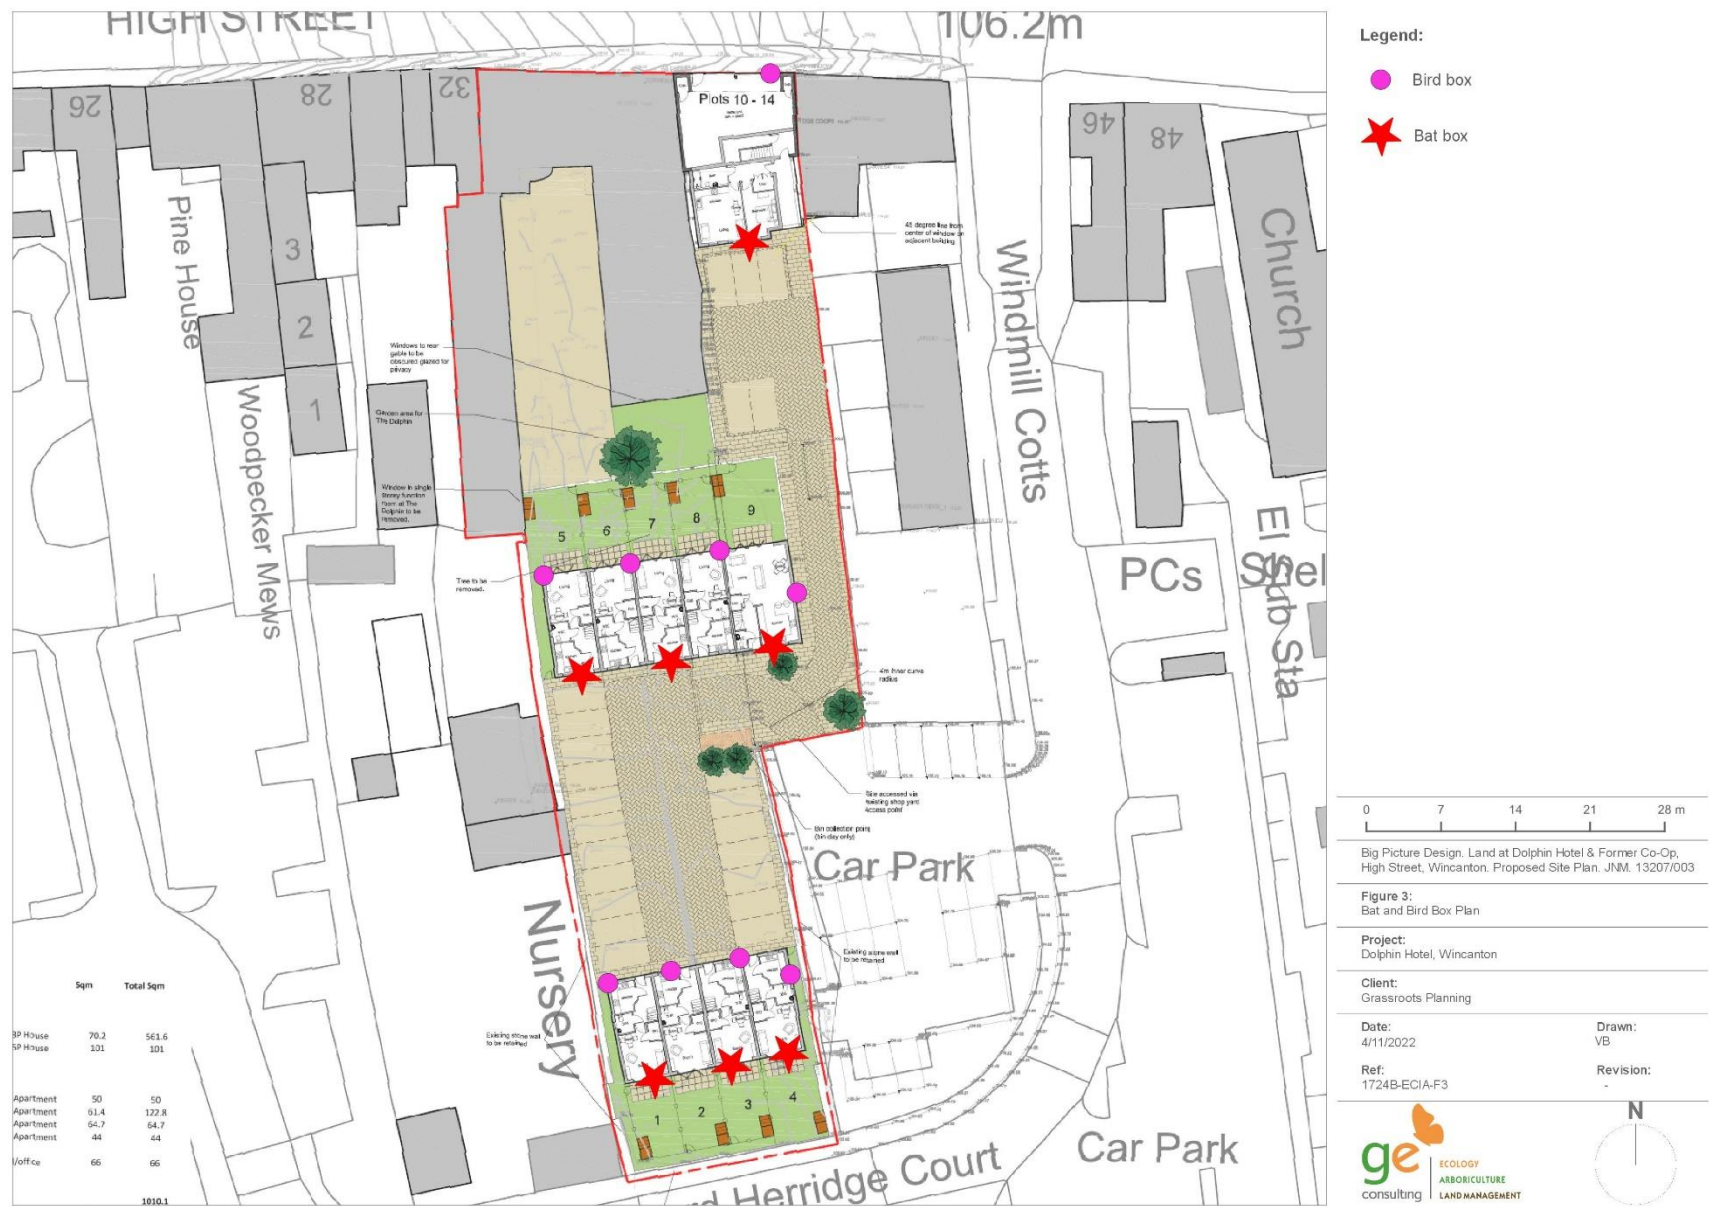
**Figure 3** shows appropriate locations for bat and bird boxes to be installed.

We recommend integral boxes as they are more permanent and self-cleaning such as the Habibat box <http://www.habibat.co.uk/> or alternatively bat and bird boxes available from <http://www.birdbrickhouses.co.uk>. the boxes are either faced with or made from the build material making them less visually intrusive than an externally mounted box. A good location for bat boxes is at the apex of a gable end with a southerly aspect. Bird boxes should not be mounted on southerly aspects as they can become too hot during the summer months. **Figure 3** indicates proposed locations for these enhancements.
